PROJECT PROFILE

Project Name: Coal Mine Closure Channel Stability Project

Product Type: Western Excelsior Xtreme Armor System™ (XAS) utilizing PP5-Xtreme with Percussion Driven Anchors (PDAs)

Project Location: Greater Dallas, TX Area

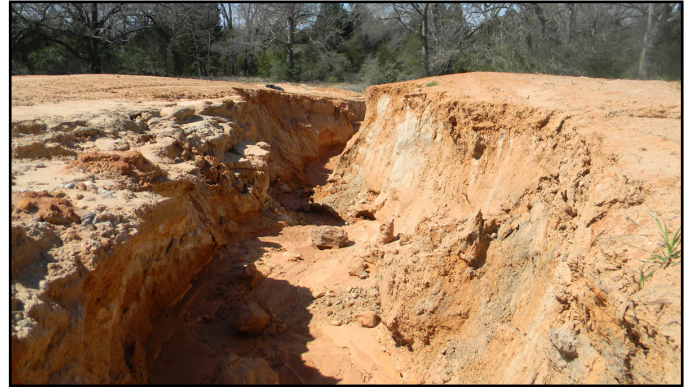
Soft, powdery soils resulted in deep gullies on the coal mine closure (top). The XAS was installed to protect the soils, reestablish vegetation, and carry site runoff (middle). Even with additional storm events, the site flourished with minimal environmental impacts (bottom).

The process of mine closure and reclamation is challenging and invites numerous conflicting objectives and requirements. In the case of a Dallas, TX area coal mine, soil moved to uncover and retrieve rich coal reserves were deposited on site for years, creating large hills of very fine sand. The sand could be easily eroded (sometimes causing gullies several feet deep) and deposited into downstream waterways. Typical storms were easily displacing the waste sand resulting in compliance issues. Rock and concrete solutions were not allowable by permit, however, a permanent solution was required. Enter Xtreme Armor System. The rainfall collected on the long, steep, erodible slopes was intercepted by a network of drainage channels reinforced by XAS. With the stormwater concentrated in protected channels, the flow could be safely delivered to the receiving waters. The XAS solution was permanent with minimal visual footprint and met the ecologically friendly requirements of the permit.
