PROJECT PROFILE

Project Name: N Schultz Pass Road Development

Product Type: Western Excelsior Xtreme Armor System™ (XAS)
utilizing PP5-Xtreme with Percussion Driven
Anchors (PDAs)

Project Location: Flagstaff, Arizona

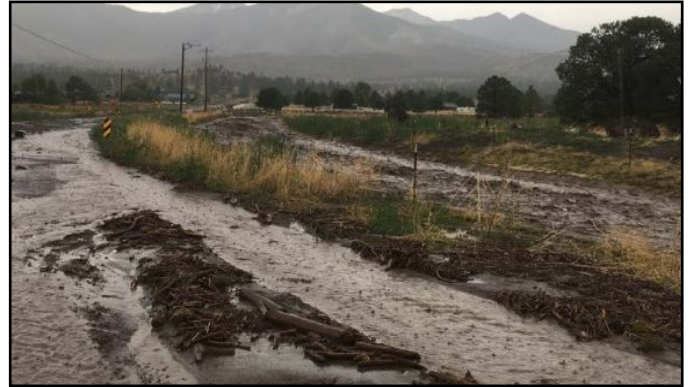
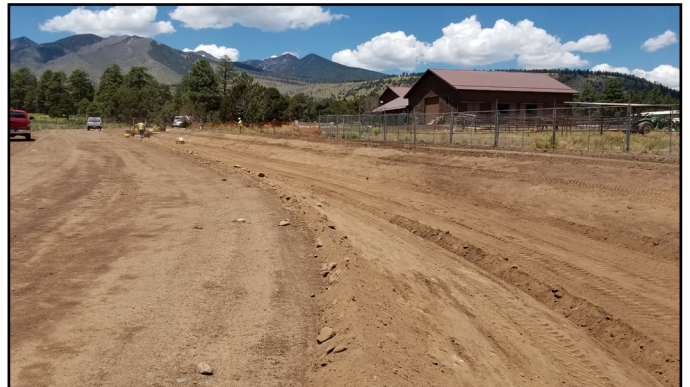
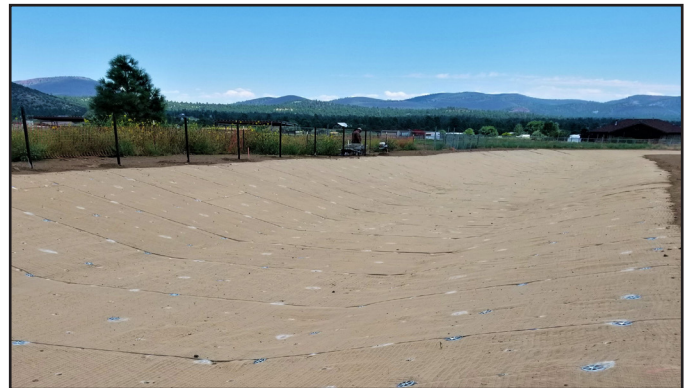
Fire-stricken ground and an 1000-yr storm event resulted in massive channel erosion (top). Remediation started by cleaning and regrading the channel (middle), and the installation of the Xtreme Armor System (bottom).

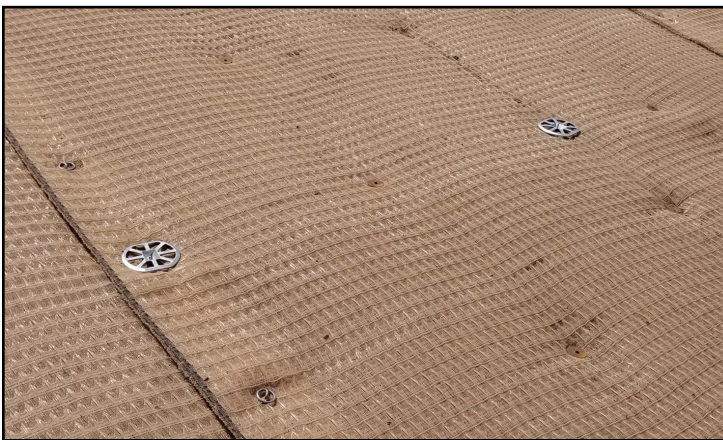
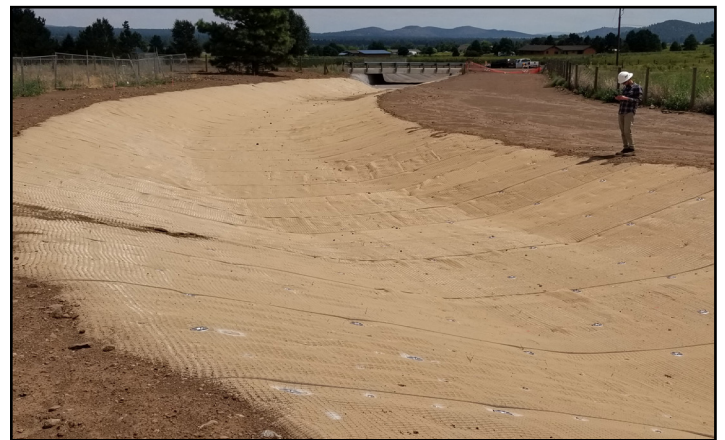
Percussion driven anchors were installed at 4 ft intervals across the HPTRM, with twist pins installed intermittently (left). The finished install of the ARVS design resulted in a low-impact design in the drainage channel (right).

Due to the shape and size of the flood structures, the HPTRM was installed perpendicular to the channel flow. This direction of matting installation is a bit unconventional, as most installers choose to install parallel to water flow, but for this project the direction was decided upon as it would result in ZERO material waste. The HPTRM could be cut to fit the channel dimensions specifically. The XAS system can be installed in either direction as long as proper shingle-style overlaps occur in the direction of water flow. Once the erosion control matting was placed, the percussion driven anchors were installed along seams and every 4 ft across the matting. The PDAs created a working check slot to slow soil movement along the bed, while resisting pull-out up to 1000 lbs./ft. Additionally, 8-inch twist pins were installed as added fastening support. The twist pins are an inexpensive fastener that help add HPTRM-to-soil conformance using a screw-like install resulting in nearly 150 lbs. of pull-out resistance in loam to clay soil types. Finally, 12-inch-long straight wire pins were installed between the rows of PDAs and twist pins, as a final stop-check for system strength.
