PROJECT PROFILE

Project Name: Sioux River Bank Stabilization Project, Structure 103/4

Agency: Western Area Power Administration, Fort Randall, Sioux City, Iowa

Product Type: Western Excelsior Xtreme Armor System™ (XAS) utilizing PP5-Xtreme with Percussion Driven Anchors

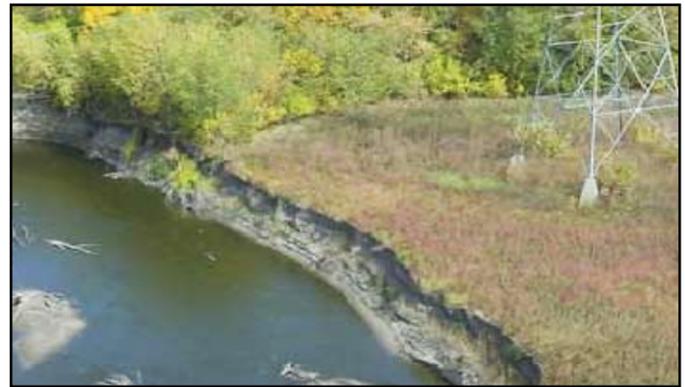
The highly eroded banks along the Sioux River (top) needed an overhaul. XAS in conjunction with PDAs (middle), protected the soils and vegetation. One year later the site remains stabilized (bottom).

The highly eroded banks were cut back to a more manageable 3:1 (H:V) slope grade. The High-Performance Turf Reinforcement Mat (HPTRM) was installed down the slope banks over a prepared and seeded soilbed. Once in place, the HPTRM was secured by PDAs and washer pins at a staggered spacing. Together, the HPTRM and PDAs form a system that offers strength and support, resistance to storm surge waters, and reinforcement of the vegetation stems and roots. In addition to the XAS system, a rock toe was installed at the normal waterline. The goal of the rock toe was to dissipate scour potential in areas that would not promote long-term vegetation establishment.
