PROJECT PROFILE

Project Name: Price Ravine Slope Stability Project
Installation Date: April, 2012
Product Type: Western Excelsior Xtreme Armor System™ (XAS) utilizing PP5-Xtreme with Percussion Driven Anchors (PDAs)
Project Location: Junction City, KS

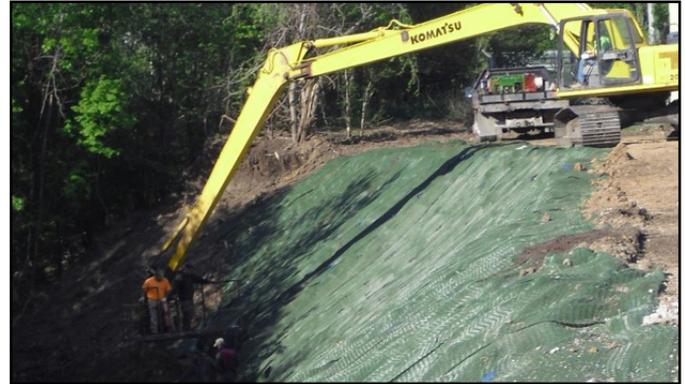
Modified equipment aided the installation of the Xtreme Armor System on the inaccessible steep slope (top). The HPTRM was installed with PDAs and hydraulically mulched (middle). Even through a summer drought, the site saw full vegetation within months (bottom).
